FAILURE PREDICTION AND ANALYSIS OF REAR AXLE HOUSING OF A COMMERCIAL UTILITY TERRAIN TRUCK

Abstract— In the present study utility vehicle rear axle housing was selected to study the failure analysis experimentally and numerically. The failed rear axle housing was undertaken to check its integrity which includes a visual examination, chemical analysis, microhardness test, and metallographic tests to evaluate the failure. Failure analysis of a rear axle housing used in a utility vehicle was studied to determine stress concentration area. Based on field study strain gauges are mounted on failed parts to determine stress intensity and joint analysis were validated with Finite Element Analysis results. SEM (scanning electron microscope) was used to examine the failure zones. Under this analysis, it is seen that the rear axle housing suffered a fatigue-induced fracture. The fracture was initiated at the weld joint between the back plate and rear axle housing, where a stress concentration was created. This stress concentration was higher than the stress concentration considered at the time of design which results in the breakage of the housing into two parts. Also, stress concentration w

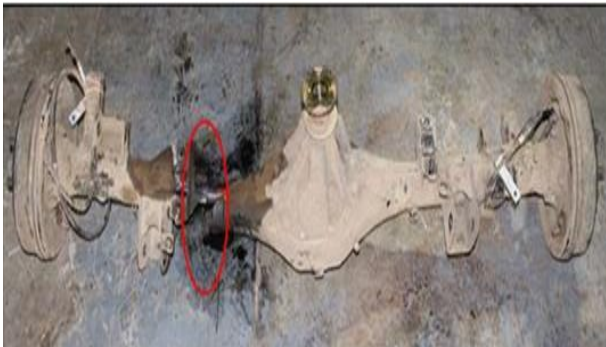
Fig. 2 Fracture of the rear axle housing at the left side

Beam housing / rear axle housing failed from the left side & fractured into two pieces from the end of the weld joint of the backplate & beam housing. Fracture initiated from the end of seam weld on backplate at 13 to 14 mm below tube seam weld. At fracture initiation, clear beach marks are observed. No hit or dent mark or other damage was found near fracture initiation. The fracture can be determined as brittle when the surface is seen flat, a mixture of ductile and brittle when the surface has a moderate degree of roughness, ductile when the surface is more on the rough side.

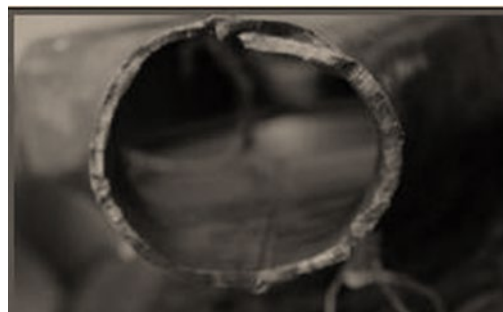
The broken component shows a moderate degree of roughness, so it must be a combination of a ductile and brittle type of fracture. As shown in Fig. 3.

Fig. 3 Rear axle housing broken piece

SEM (scanning electron microscope) was used to examine the fractured surface to characterize the fracture micro mechanism. The fracture surface contains ratchet marks. The ratchet marks indicate multiple origins and relatively high total stresses. Ratchet marks can result from high stress on the part or from high-stress concentrations. The combination of many ratchet marks and a small overload zone indicates that the load was light, but there were high-stress concentrations.

From these observations, it is clear that fatigue cracks have initiated at stress concentration points leading to the fracturing of the rear axle housing. The badly welded region can lead to a high-stress concentration, but can also cause fatigue crack initiation during short service time. A fatigue crack can form when the local stress exceeds the material yield strength. Since steel resistance to fatigue initiation, is proportional to its yield strength, the low properties of the steel left it open to fatigue initiation. The area of final overload fracture is small, approximately 15% of the total area, indicating that the material was adequate for the applied stresses. Fig. 4 shows a specimen under 30X magnification having flat as well as moderate roughness, which indicates the material is a mixture of both ductile as well as brittle failure.

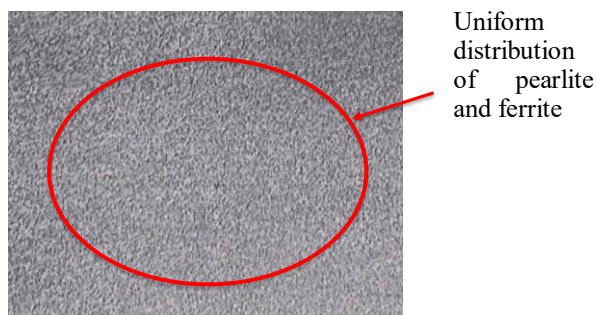
The metallographic microstructure is shown in Fig. 4 for the rear axle housing. It shows an element mainly formed by uniformly distributed ferrite & perlite. The presence of uniform perlite indicates that the material suffered a heat treatment of quenching & tempering.

Fig. 4 Microstructure of the material

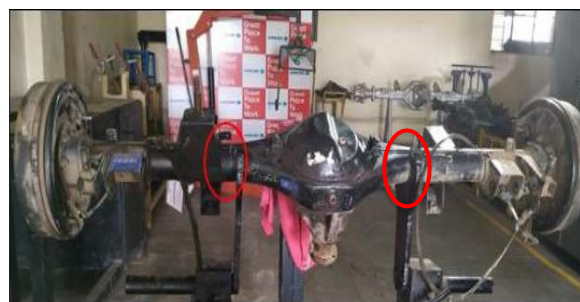
Therefore, Stress on the left side is **261.58 MPa** and Stress on the right side is **216MPa**

Fig. 5 Mounting of strain gauges on the axle housing to measure contact stresses

Strain gauges mounting position were shown by the red circles in Fig. 5. With this strain gauge arrangement, stress values are received in the running condition on the rear axle housing.

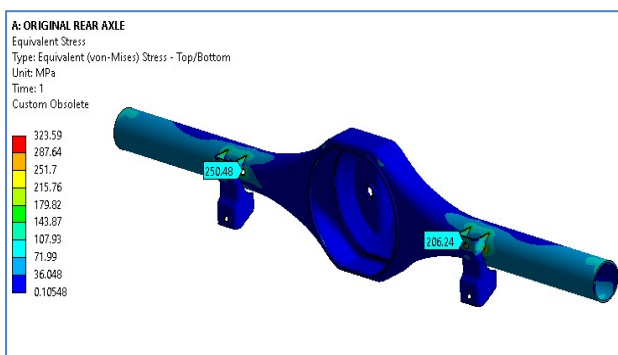
Fig. 7. Von Mises stress plot for 3.5 mm thickness

Fig. 7. shows the stress distribution of the original rear axle housing with 3.5 mm thickness. Left side stress distribution (250.48MPa) is higher than the right-side stress distribution (206.24 MPa) by 21%.

Table 3 shows when the thickness was 3.5 mm, left side contact stress was 250.48 MPa and right side contact stress was 206.24 MPa at which axle housing was failed. To avoid the failure, axle housing thickness was increased from 3.5 mm to 3.7 mm, 4 mm & 4.2 mm and gets the respective left side and right side contact stress values. When thickness increased to 3.7 mm, contact stresses decreased by 13% but 3.7 mm thickness material is not available in the market. Hence, 3.7 mm thickness is not feasible from the production point of view.

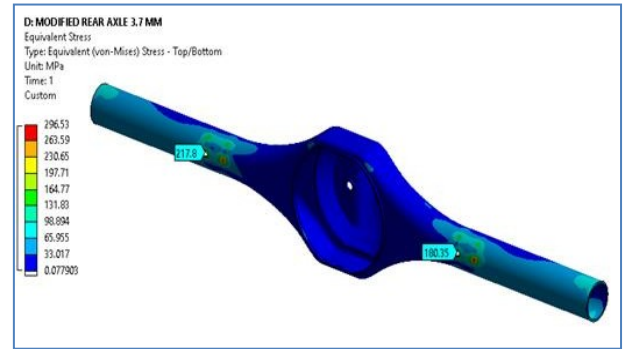
Fig. 8. Von Mises stress plot for 3.7 mm thickness

Left side stress distribution reduced up to 217.8 MPa from 250.48 MPa and right side stress distribution reduced up to 180.35 MPa from 206.24 MPa. The thickness is from 3.7 mm to 4 mm and it is given the following which is shown in Fig. 9.

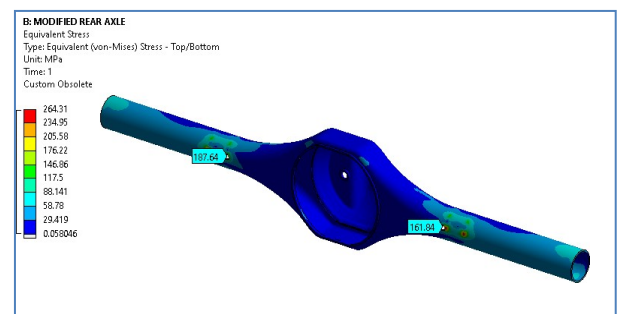
Fig. 9. Von Mises stress plot for 4 mm thickness

Left side stress distribution reduced up to 187.64 MPa from 217.8 MPa and right side stress distribution reduced up to 161.84 MPa from 180.35 MPa. The thickness from 4 mm to 4.2 mm was given which is shown in Fig. 10.

Then thickness increased to 4.2 mm and contact stresses decreased by 33%. If 4.2 mm thickness material is used for production it will increase the weight of the axle housing by 20% which will affect the vehicle performance. So, 4.2 mm thickness is not acceptable. Then thickness changed to 4 mm and checked contact stresses, which was decreased by 24% and weight increased by 14%. 4 mm thick raw material is also available in the market. Hence from cost, manufacturing and performance-wise 4 mm thickness is the optimized thickness. Therefore, 4 mm thickness for rear axle housing is proposed.

To a reduction in contact stresses on the rear axle housing element, a geometric design change of the element was proposed. FEA was done on 3.7 mm, 4 mm and 4.2 mm thickness. Finally, 4 mm thickness was selected. This was an optimized thickness from manufacturing, cost and vehicle performance. Therefore, in the proposed design, the thickness of the rear axle housing beam was increased by 0.5 mm. This rear axle element was modelled using the same loading and boundary conditions applied for the failed element. In the proposed case the maximum stresses were observed on the section of the element, with the highest value of 187.64 MPa approximately (24% improved as compared to the original one).

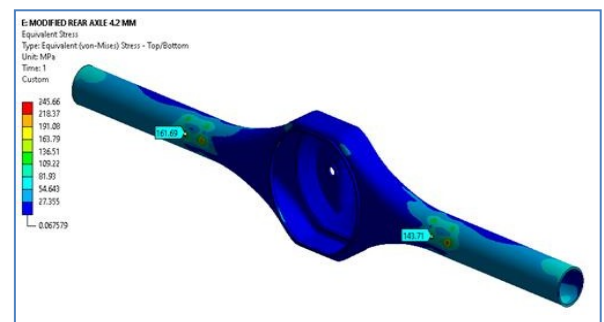
Fig. 10 Von Mises stress plot for 4.2 mm thickness

Left side stress distribution reduced up to 161.69 MPa from 187.64 MPa and right side stress distribution reduced up to 143.71 MPa from 161.84 MPa.
