FAILURE PREDICTION AND ANALYSIS OF REAR AXLE HOUSING OF A COMMERCIAL UTILITY TERRAIN TRUCK

Abstract— In the present study utility vehicle rear axle housing was selected to study the failure analysis experimentally and numerically. The failed rear axle housing was undertaken to check its integrity which includes a visual examination, chemical analysis, microhardness test, and metallographic tests to evaluate the failure. Failure analysis of a rear axle housing used in a utility vehicle was studied to determine stress concentration area. Based on field study strain gauges are mounted on failed parts to determine stress intensity and joint analysis were validated with Finite Element Analysis results. SEM (scanning electron microscope) was used to examine the failure zones. Under this analysis, it is seen that the rear axle housing suffered a fatigue-induced fracture. The fracture was initiated at the weld joint between the back plate and rear axle housing, where a stress concentration was created. This stress concentration was higher than the stress concentration considered at the time of design which results in the breakage of the housing into two parts. Also, stress concentration w

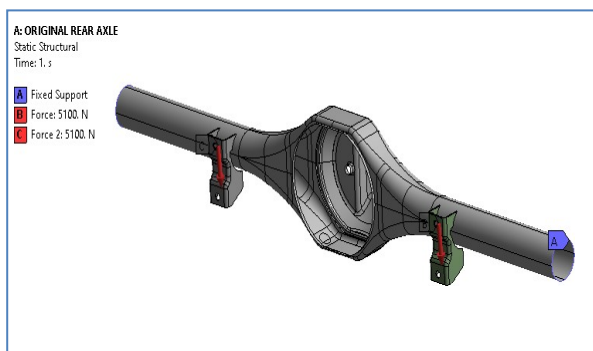
Fig. 6 Loading condition in ANSYS

rear axle housing was geometrically modelled as shown in Fig. 6 Hexagonal elements with a size of 2 mm were used in the FE mesh. The mesh had a total of 25277 elements. The size of the elements and mesh was selected after performing a series of iterations with the same loads and using different mesh sizes. It was noted from the iterations that the values of the stresses in the element varied considerably, for elements smaller than 2 mm, making it high values related to singularities caused by small elements. For elements bigger than 2 mm the stresses were not represented as the size of the elements were higher than the contact region. Following are the loading, boundary, and contact conditions of the model:

1. A fixed contact in zone A (end of the rear axle housing)
2. Lateral load B & C, assumed constant in this analysis to simplify the modelling, with a value of 5100 N and applied on the backplate.

The analysis and calculations of maximum stresses were performed with and without the backplate, to highlight the places of higher stresses in the element. It is observed that there is no major change in the readings after removing the jack mounting plate from the welding joint. After this trial the trial by changing the thickness of the material from 3.5 mm to 3.7 mm, 4 mm and 4.2 mm.
